Moisture Testing Procedures

Moisture Testing And Documentation Moisture Testing Procedures (cont.)

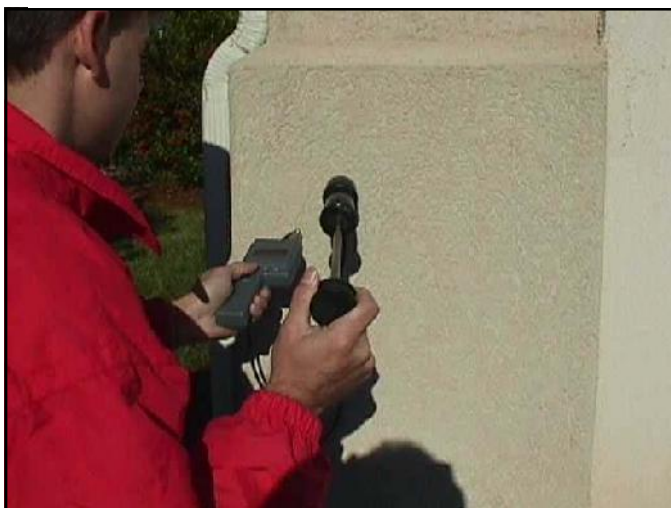
An electrical resistance-type meter (such as the Delmhorst J-2000, BD-2000, BD-2100 or similar meter) with at least 3” probes should be used to determine relative moisture levels in the substrate or framing wood. Any reading 19% and above is considered above normal. Double-check all high readings. Flashing, nail heads, screw heads, and other materials can give false high readings. If you have any doubt about the reading, move the probes 1” in any direction from the original location and re-test the area.

To probe for a moisture reading, the inspector will first drive two steel pins through the EIFS into the wall. The inspector should note whether the substrate or framing seems firm or soft, keeping in mind that different substrates may be used on the home. The pins are withdrawn, and then replaced with the Teflon-coated probes of the Delmhorst meter. **CHECK YOUR PINS TO ENSURE THAT THE TEFLON COATING IS NOT SCRATCHED OR DAMAGED, WHICH COULD GIVE FALSE READINGS.** Record the meter reading and note the “feel” of the framing or substrate wood. The small inspection holes are sealed with an appropriate sealant, preferably matching the color of the EIFS as closely as possible.

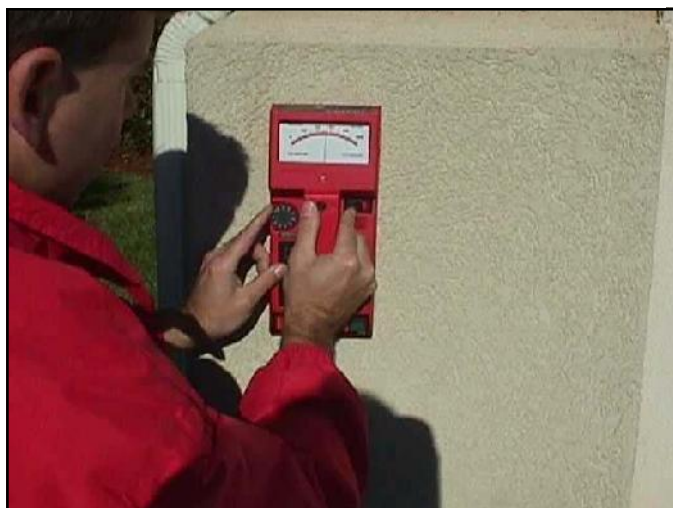
The Tramex Wet Wall Meter works well for determining the size of a known high moisture area. The Tramex Wet Wall Meter cannot be used to determine a moisture level. It can only be used to help find potential areas of high moisture and to “map” the relative size of a high moisture area.

The Tramex Scanner will give false positive readings when placed over nails, pipes, wiring or other metal elements of the wall. Any high reading detected by the Tramex Scanner MUST be verified using an electrical resistance-type meter, such as the Delmhorst BD-2000 with 3” probes. Moisture-Free Warranty does not recognize any moisture reading using the Tramex Scanner without verification using an electrical resistance probe meter.

The Tramex Wet Wall Meter can be used to “map” the size of areas of high moisture once the area has been proven to have high moisture levels using an electrical resistance meter.
